## **FIELD INSPECTION REPORT**

Project Name: Mountain Valley Pipeline		Inspector:	Matthew Grant		
Inspection Date:	Monday, November 16, 2020 Project Contact: Brian Cla		Brian Clauto		
Spread H: Roanoke	MP 232.5-231.5 236.4-235.7, 235.2- 235.6 ATWS 645, 645A, 725, 1223 AR MN 276.03, AR 28	Weather:	Wet		
ACTIVE STAGE OF CONSTRUCTION: (Check all that apply)					
☐ Tree Felling	☐ Clearing/Grubbing ☐ Gra	ding	hing	Strir	nging/Welding
☐ Lowering/Backfilling	☐ Final Grading ☐ Ten	np. Stabilization  Perm.	Stabilization	Dor	mant
			Yes	No	N/A
Are controls installed and implemented in accordance with the approved erosion and sediment control plan and stormwater management plans?					
Are all control measures properly maintained in effective operating condition in accordance with good engineering practices and, where applicable, manufacturer specifications?

## FIELD INSPECTION PHOTO LOG

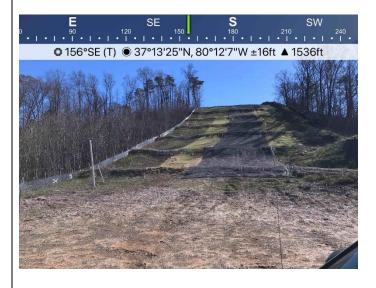
Figure 3: Near MP 236.4 the area is stabilized.

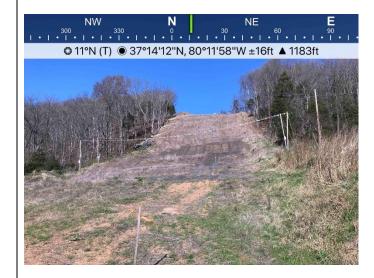
Figure 4: Near MP 235.2 the area is stabilized.
